CABAZON WATER DISTRICT CONTRACT DOCUMENTS FOR RESERVOIR NO. 1 INTERIOR RECOATING

ADDENDUM NO. 2

Final Report Coating Evaluation

1MG Water Storage Tank

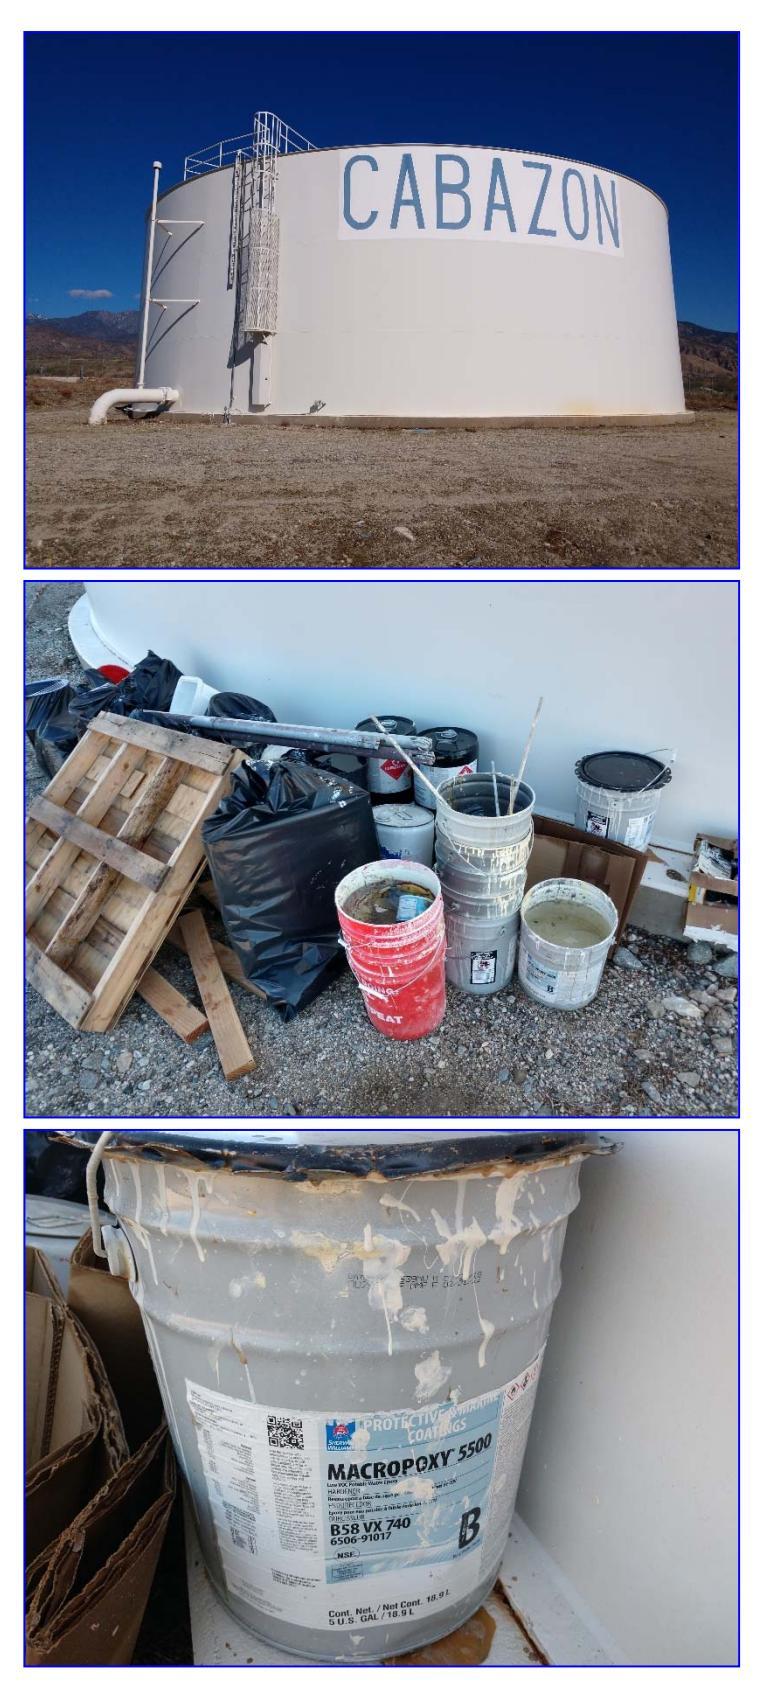
Photo 1 – Exterior – Overview of the Cabazon 1MG Tank

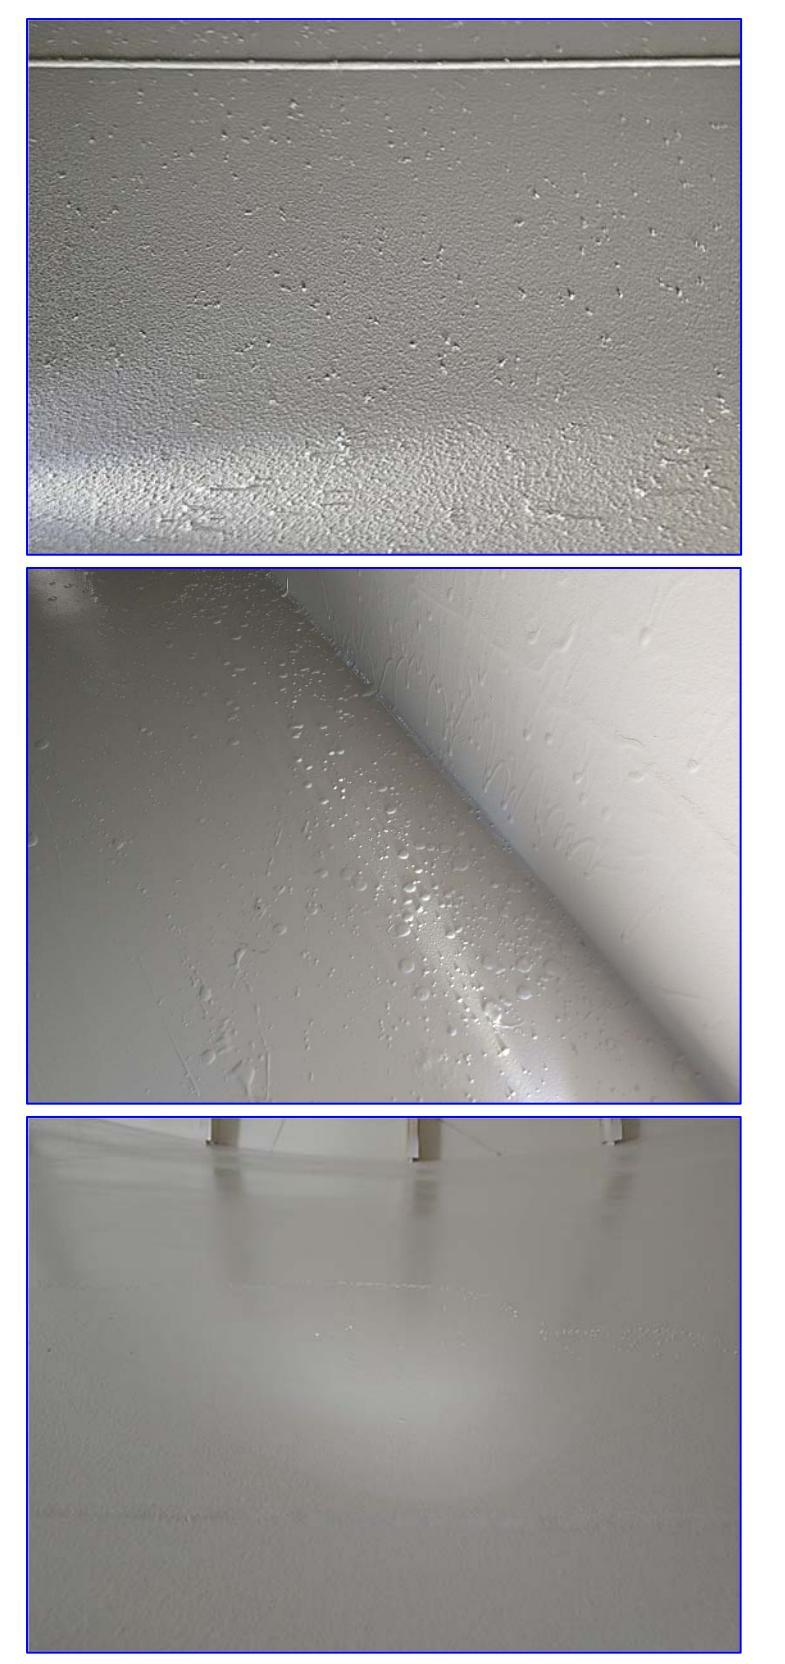
Photo 10 – Interior – View of lower shell course with entrained debris.

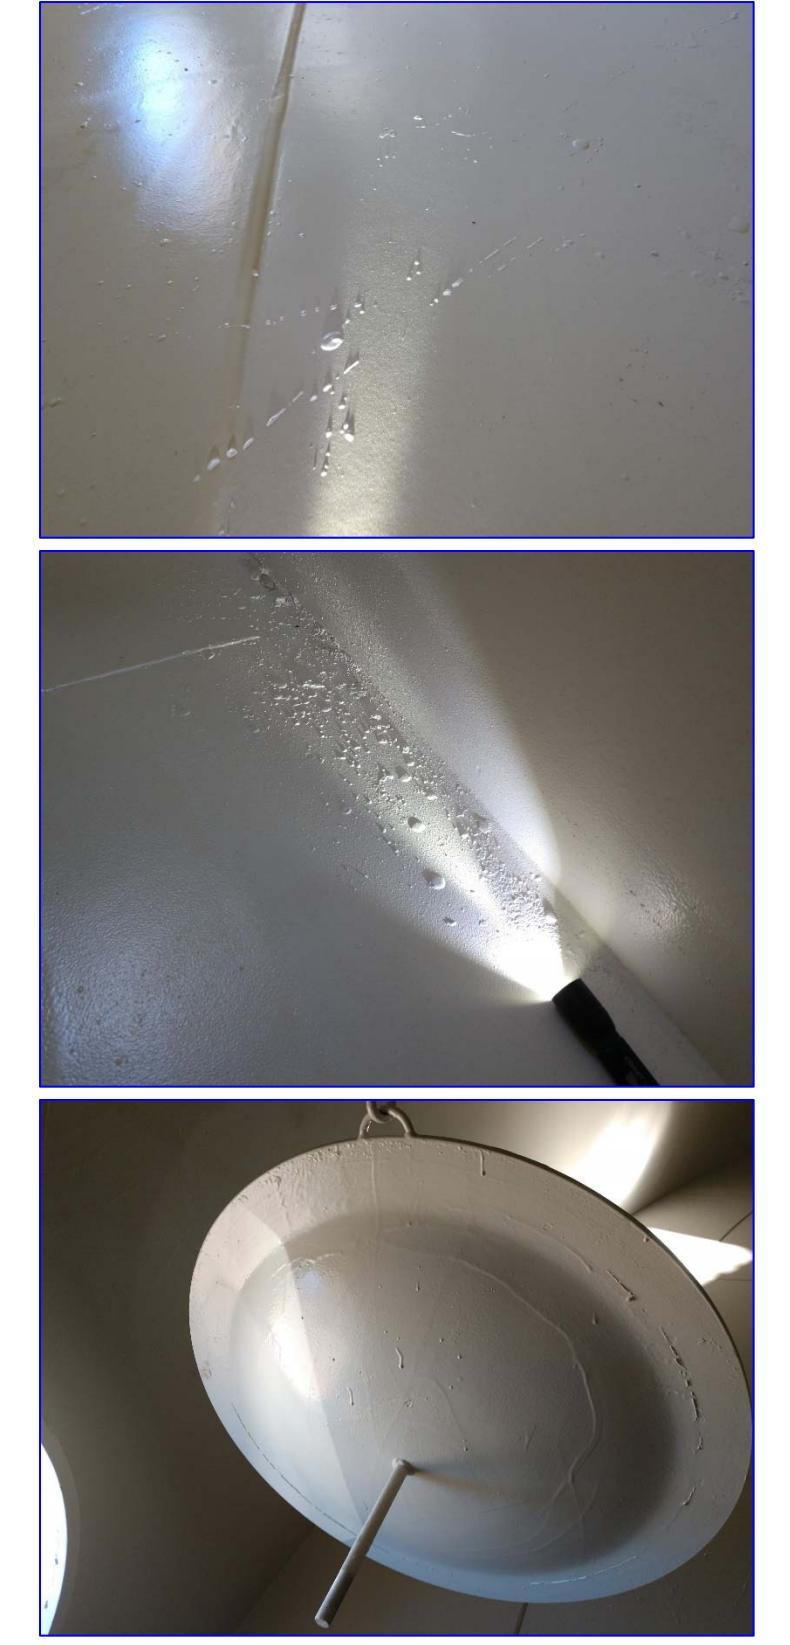
Photo 13 – Interior – View of paint drips and splatters upon the floor surfaces.

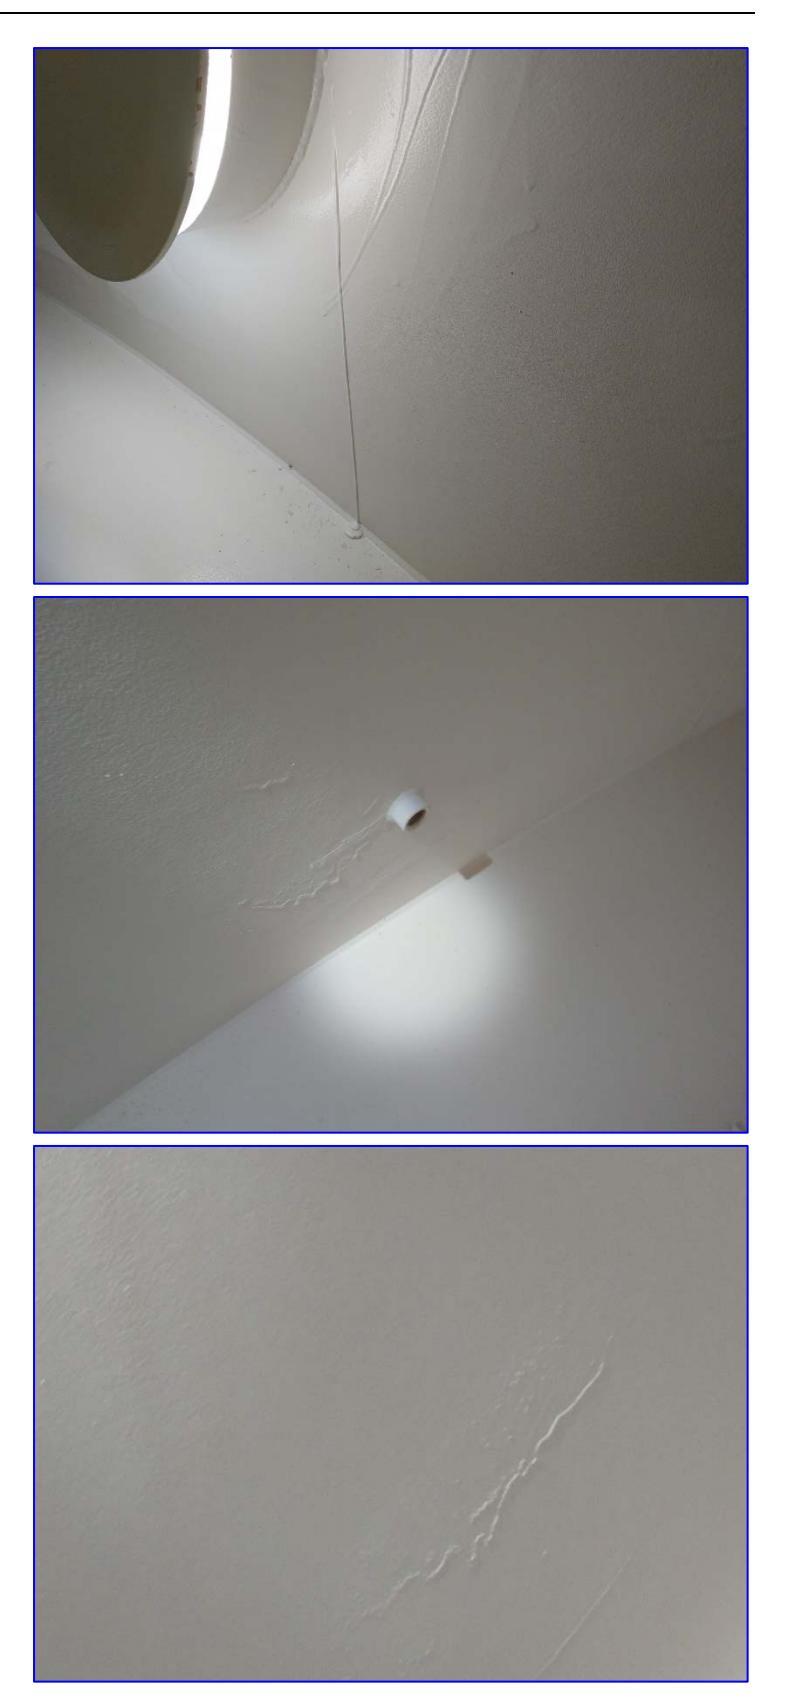
Photo 16 – Interior – View of lower shell course adjacent to the manway which exhibits improper spray application.

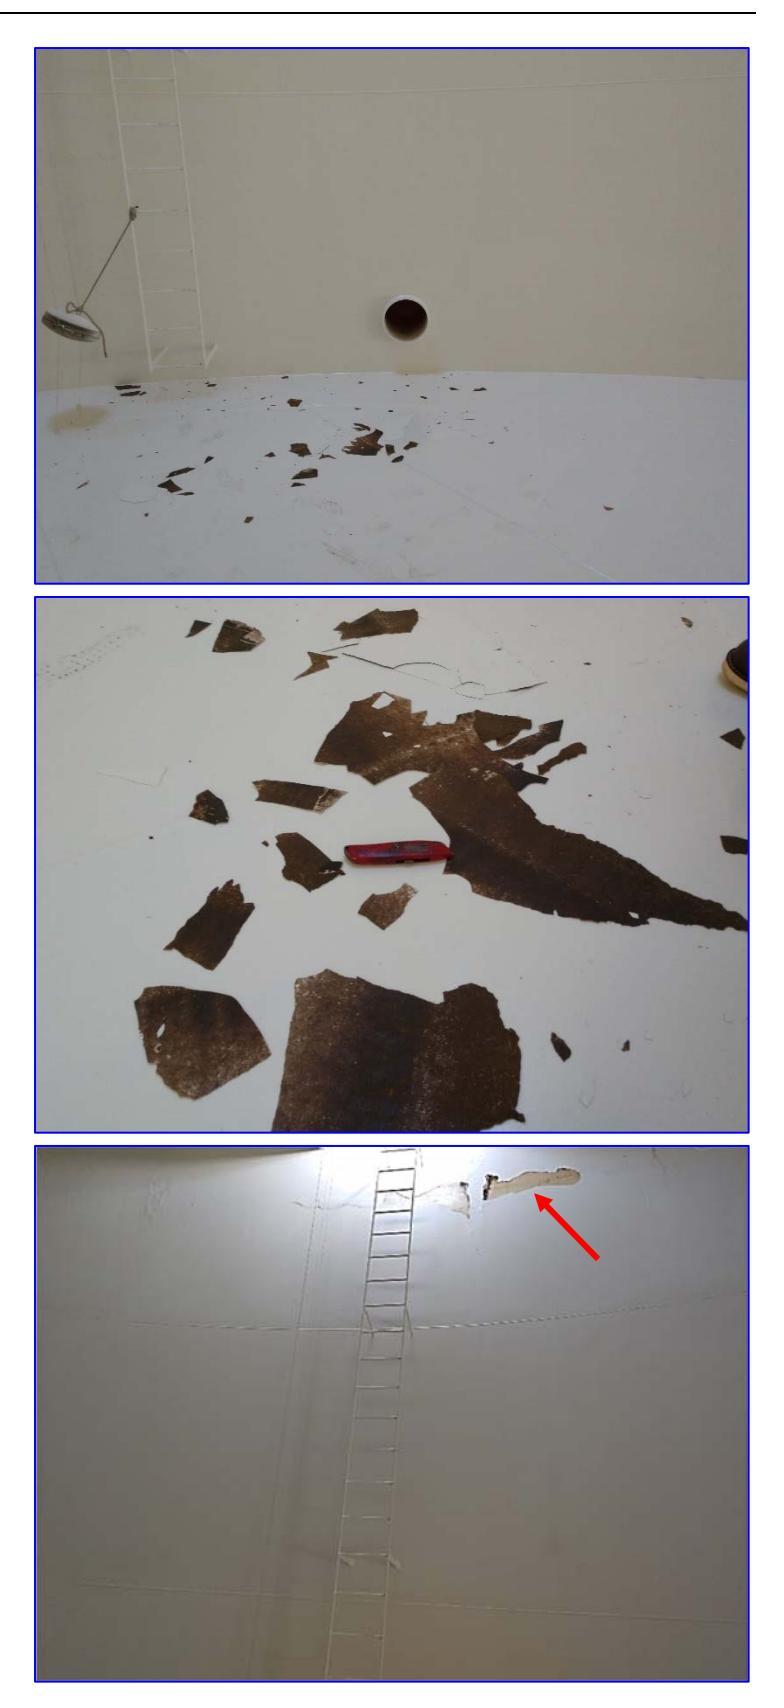
Upon entry into the tank, attention was immediately drawn to the area adjacent to the interior ladder area where numerous large coating pieces were found resting on the tank floor. The pieces of lining were as large as 12 square inches in size and had disbonded from the upper shell adjacent to the ladder at about the mean water level if the tank was in operation. The backside of the coating pieces had a soft, dark, and sticky residue similar to an oil. The pieces were measured with a micrometer and found to be in excess of 50 mils (0.050") thick.

Photo 21 – Interior – View of the area that has generated the coating prices that had fallen to the tank bottom. This major areas of defects is at an apparent mean water level when the tank is in service.

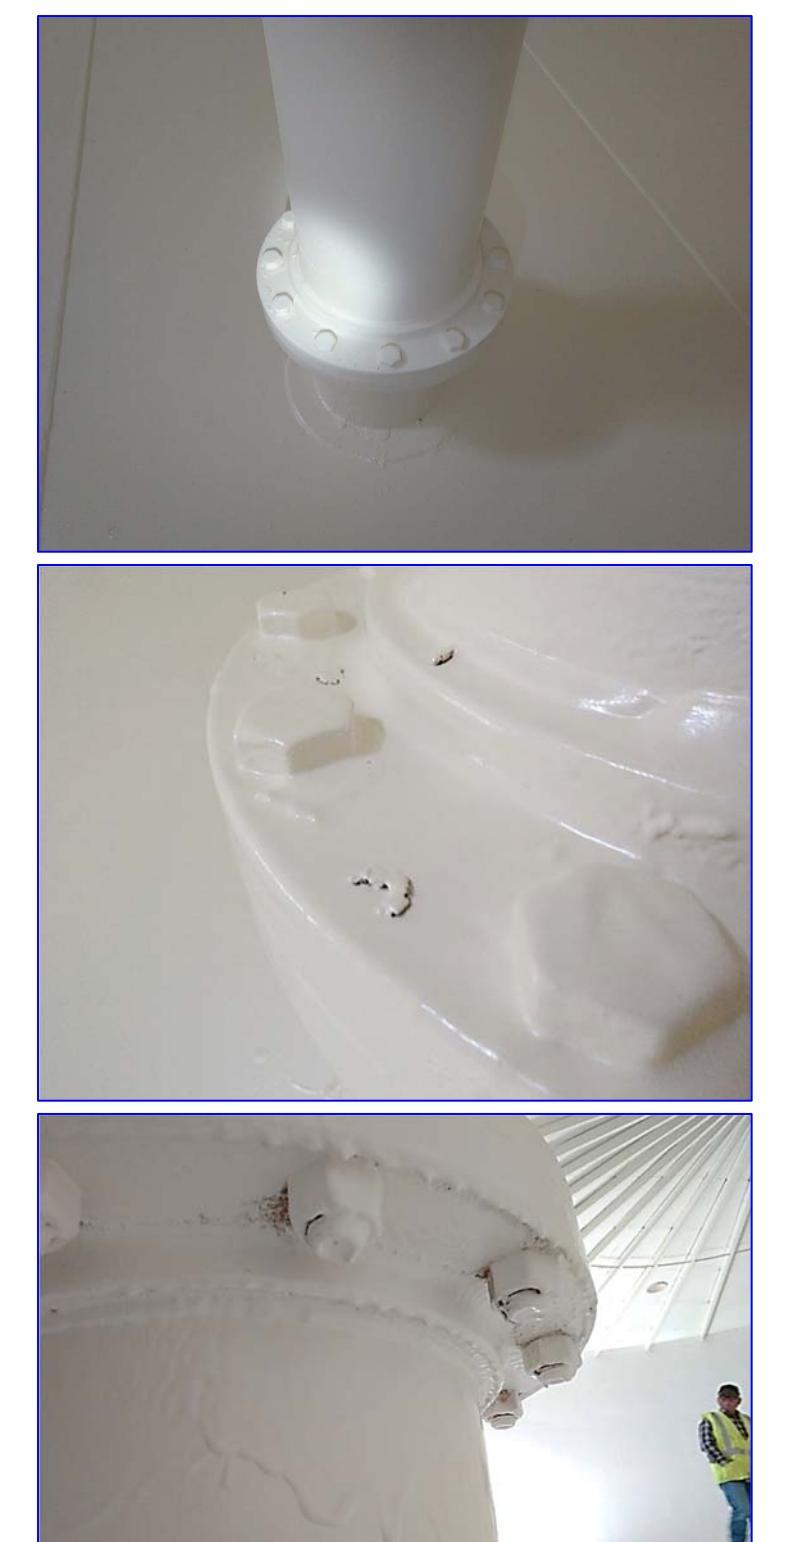
Photo 25 – Interior – Overview of the tank's internal overflow pipe.

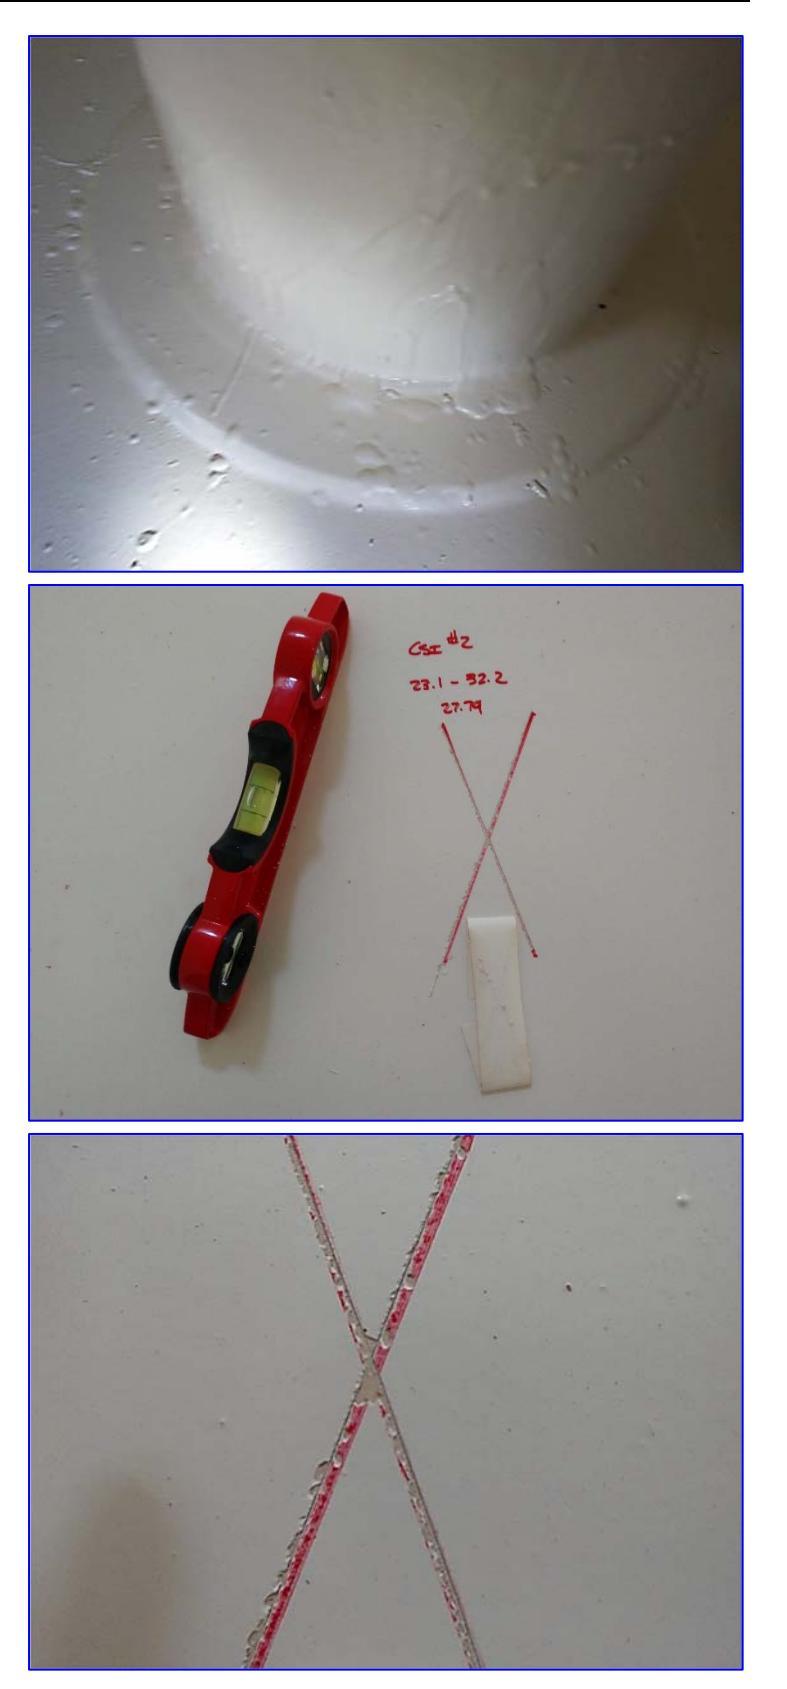
Photo 28 – Interior – Closeup view of the coating at the overflow pipe penetration at the floor with excessive coating thickness and defects.
